High Accuracy Temperature Profiling on Tangential Boiler

Huxian Second Thermal Electric Plant, China

300MW Tangential Coal-Fired Boiler

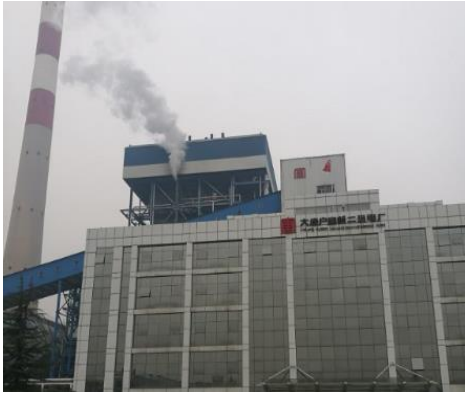
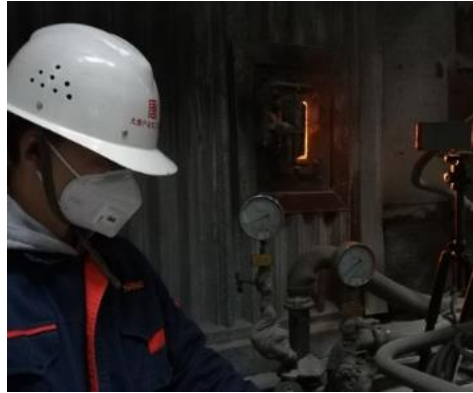
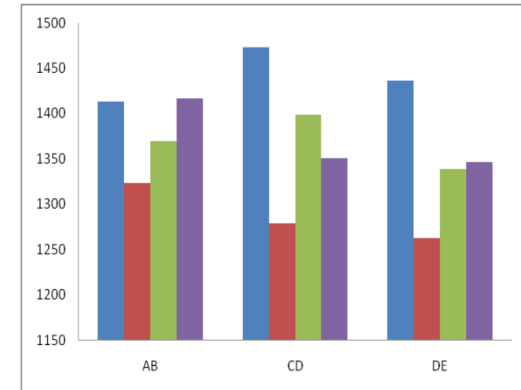
- Results identified major differences between CD1 and CD2, as much as, 194°C that severely affected the furnace temperature distribution
- Plant operators now have a tool to troubleshoot combustion and temperature distribution problems, as well as, a method to check their corrective actions
