# CASE STUDY

## Renovation of Flame Detection System

### On Wall-fired Boiler

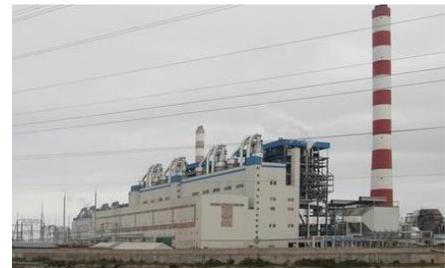
The Haiphong Power Plant is a 4x300MW coal-fired power station in Haiphong province, Vietnam. The wall fired boiler was supplied by Dongfang Boiler Group Co., Ltd. (China). Each boiler has 24 igniter oil burners and 24 main coal burners, all are equipped with a competitor's flame detector

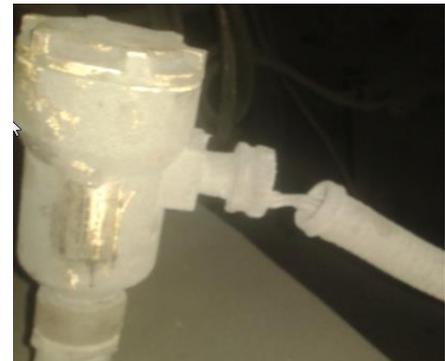
There was a concern at the Hai Phong power plant that flame scanners were prematurely malfunctioning and failing during normal operations. The suspected cause for this behavior is exposure to high temperatures in the vicinity of the installation.

- 1) The existing flame scanners have a working temperature range of -20 to +70°C. When temperatures exceed the upper working range, the electronics can suffer temporary and or permanent damage
- 2) In many cases, scanners will simply stop working when overheated. However, some have been observed to give incorrect alarm and flame status while overheated, then operate normal when the temperature drops
- 3) A cost effective solution that can accommodate the higher temperatures at this installation is needed

1) Gradually replace the existing split-architecture (separate scanner and amplifier) flame scanners with the W-Flame integrated scanner/amplifier detector. The higher temperature tolerance (+85°C) of the W-Flame allows it to provide critical flame status information, while the integrated design simplifies installation and allows the use of existing cables to communicate with the DCS
