CASE STUDY

Solution to Oil Guns that Jam (1)

Safe-Fire inc.

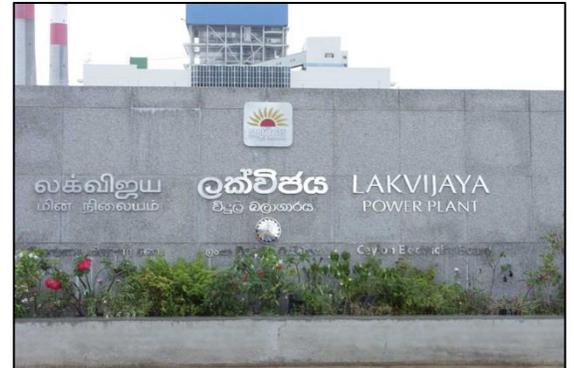
The Lakvijaya Power Plant is a 3x300MW coal-fired power station in the Puttalam District in the Northwestern Province of Sri Lanka. The tangentially fired boiler was supplied by Harbin Boiler Works (China). Each unit has 12 oil burners and 20 coal burners. Each oil burner is equipped with a QMA type oil igniter.

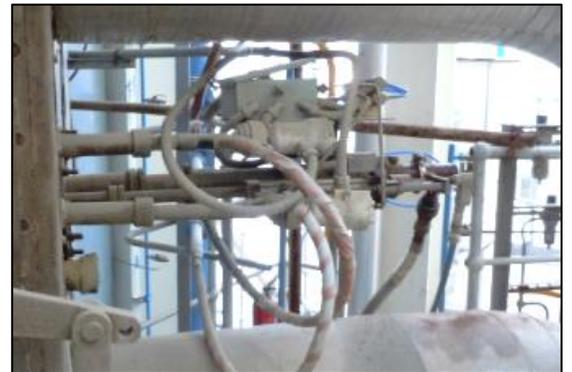
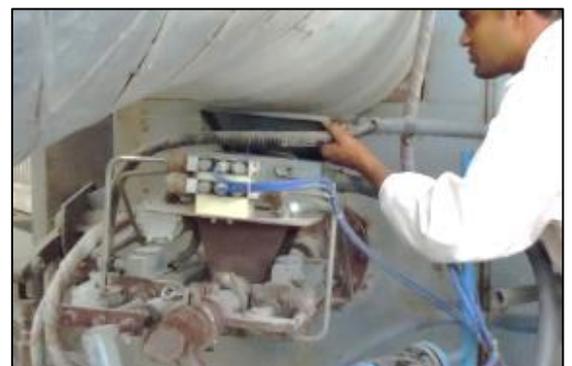
End users at the Lakvijaya power plant requested Safe Fire's assistance to troubleshoot and correct jamming and ignition problems on their oil igniters. The following issues were observed:

- 1) The solenoid valves, which are mounted on the oil guns, malfunction during operation and need frequent service
- 2) Servicing the solenoid valves and actuator are extremely tough due to their location
- 3) Oil gun bodies and spark rods jam when the solenoid valves fail
- 4) The high energy spark igniters often have a very difficult time lighting the fuel
- 5) Unsuccessful ignition causes major delays during plant startups

- 1) Relocate the solenoid valve enclosure to an open area near the oil igniter but away from the high heat zone
 - (a) Removed solenoid valve assembly from the oil igniter and re-plumbed actuator air supply

- (b) Preplaced existing solenoid valves and cabinets, and added a supply air filter with a regulator
- (c) Down-sized the existing junction box and installed the new SVC(solenoid valve cabinet) near the HESI

- 2) Adjusted Spark rod and oil gun's relative positions for optimal "light-off"
 - (a) Repositioned the spark rods to be in the atomization area of the oil gun during the ignition cycle
 - (b) Serviced and cleaned oil gun bodies and tips. Ensured the atomizer is free of obstructions
