Flame Detection System Revamp on Tiny Oil Guns in a T-fired Boiler

Heshan Power Station, China

1 x 300MW Tangential Coal-Fired Boiler

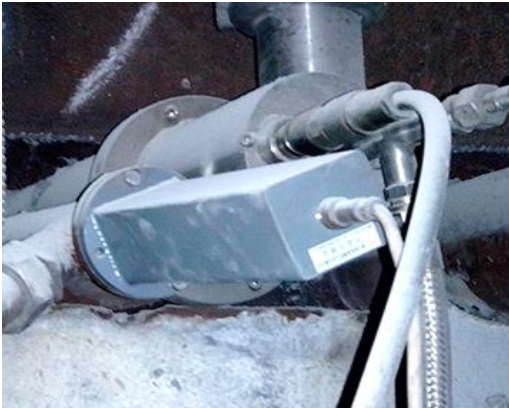
Before

- OEM Video imaging cameras were mounted near the hot furnace wall to monitor the Tiny Oil Guns
- Cameras required frequent service due to high heat exposure
- Extremely high replacement cost for cameras

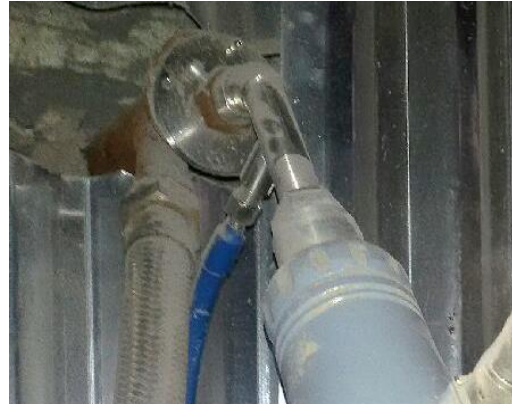
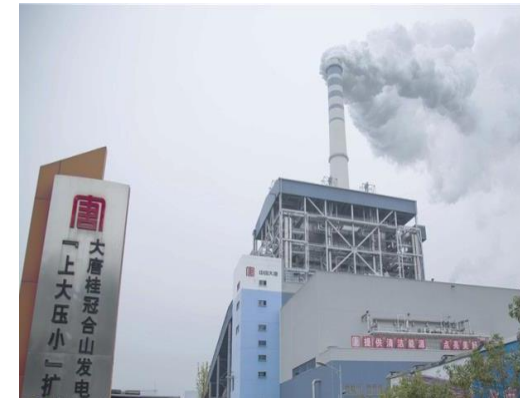
After

- Safe Fire's SU-2002 integrated flame detector was installed with a flexible fiber optic to target the flame
- Increased distance between furnace wall and scanner
- UV sensors were used for best sensitivity in light oil applications

- Increased overall flame detector reliability for the Tiny Oil Guns
- Decreased maintenance and plant start-up delays due to flame detector problems
- Significant long-term cost savings
