# Igniter and Solenoid Valve System Renovation on a Tangential Boiler

Lakvijaya Power Station, Sri Lanka  
3 x 300 MW Tangential Coal-Fired Power Station  
Boiler supplied by Harbin Boiler Works  
12 Oil Burners, 20 Main Coal Burners

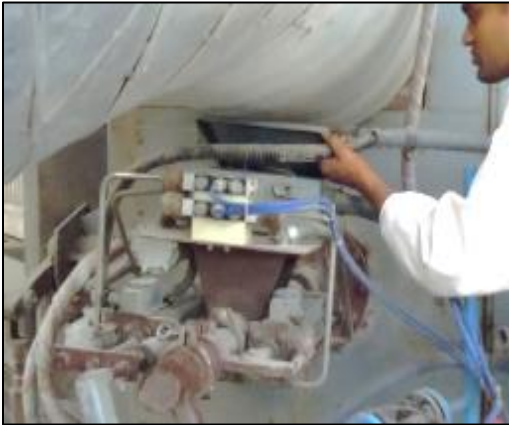
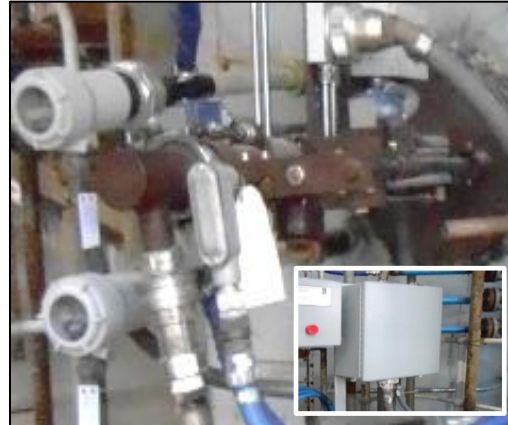
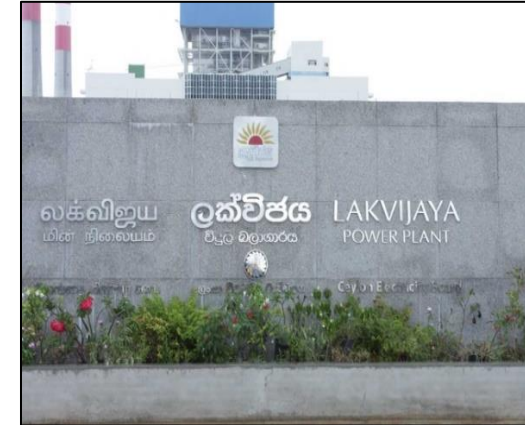
- Oil gun mounted solenoid valves and actuators fail regularly and caused jams during operation
- Poor access to Oil gun, solenoid valve, and flame scanner components
- Igniter system has difficulties lighting the fuel

- Safe Fire's engineering and service team upgraded and relocated the solenoid valve and pneumatic system
- Safe Fire also inspected the spark rod and atomizer and found that many were not properly aligned. Each were corrected for ideal light-off position

- Solenoid valves relocated away from vibration and heat, improved performance, service life, and accessibility
- 100% cold-state light off was achieved on the oil guns during the subsequent startup
- Significant fuel savings
